## Matthew Jones House

Historic Maintenance and Repair Manual

### **Final report**

Under   Project # 396574, "Matthew Jones House Maintenance & Repair Manual."

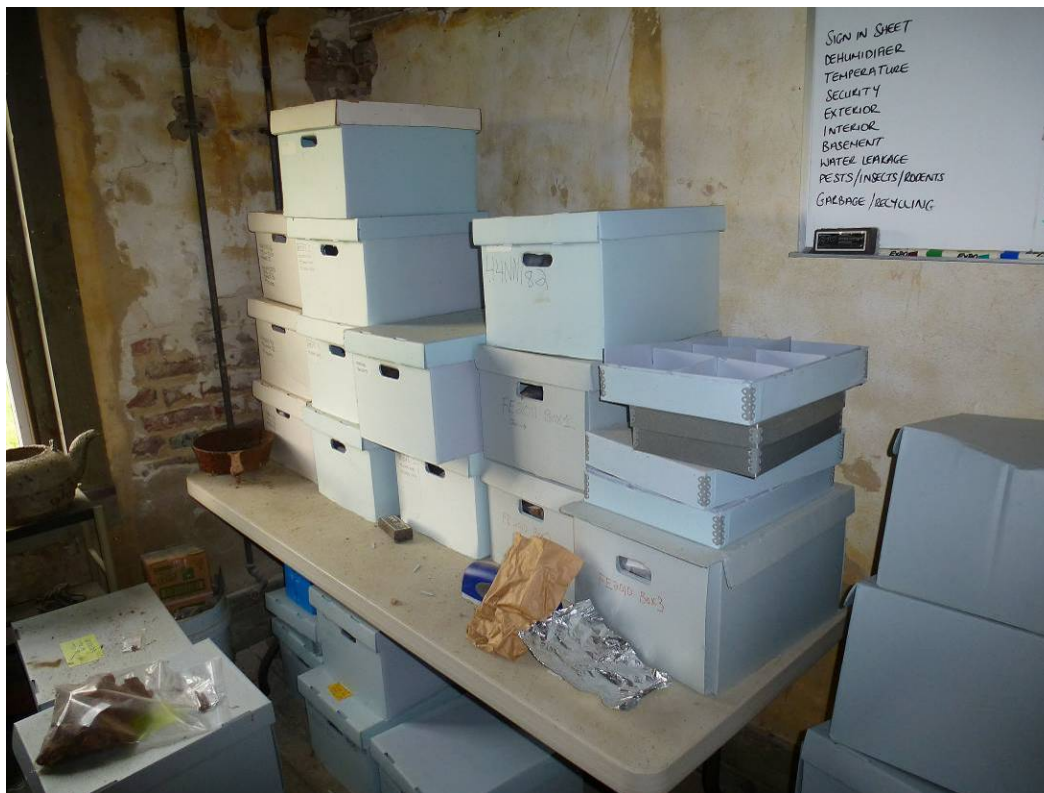
The second floor of the porch tower is currently being used as a storage area (Figure 17). The space measures approximately 9'-9 ½" x 11'-2". It has wood floorboards, wood baseboards, and a brick wall that is covered with plaster which is severely deteriorated. The ceiling is left exposed in this room. There is a window on the southwest wall.

Figure 17. Second floor of the tower in the Matthew Jones House (ERDC-CERL, 2012).

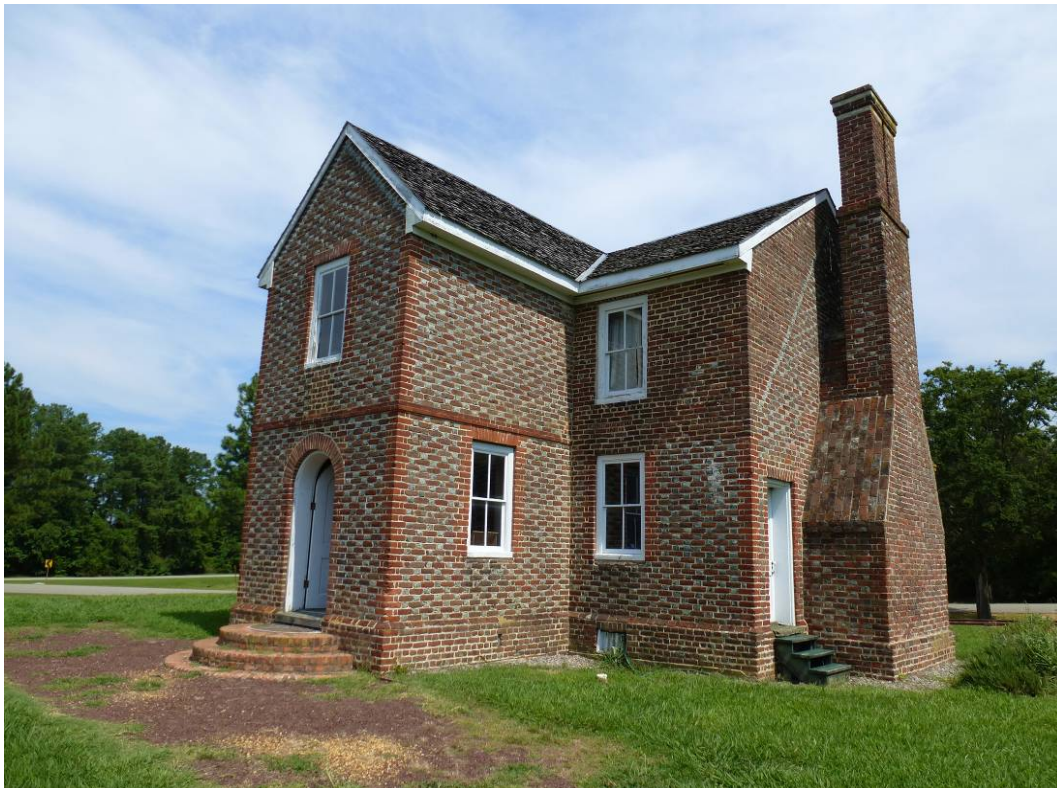
Areas that need the most attention are the brickwork on all elevations, including the two original chimneys and the second-floor wood windows (Figure 18–Figure 21). These areas are of significant historic value, and the CRM and Civil Engineering Division (CED) staffs should maintain and perform necessary repairs to ensure that the materials do not deteriorate further. Mold and lichen growth needs to be removed from the brick and mortar, the brick and mortar cleaned, and the mortar repointed in identified areas to prevent further deterioration. Care should be taken in the repair of the brick walls with materials as near to the original color as possible and with similar mechanical properties as the original brick and mortar, especially the glazed headers, the rubbed brick quoins, lintels, and jambs, and the grapevine mortar technique used.

Figure 18. South oblique with two-story porch tower (ERDC-CERL, 2012).

The CRM staff needs to immediately hire a professional brick mason knowledgeable in local brick structures. The mason should perform a thorough investigation of all brick in the Matthew Jones House to determine which bricks are too far gone and to determine the type of deterioration that is attacking the bricks (e.g., mechanical deterioration or chemical deterioration).

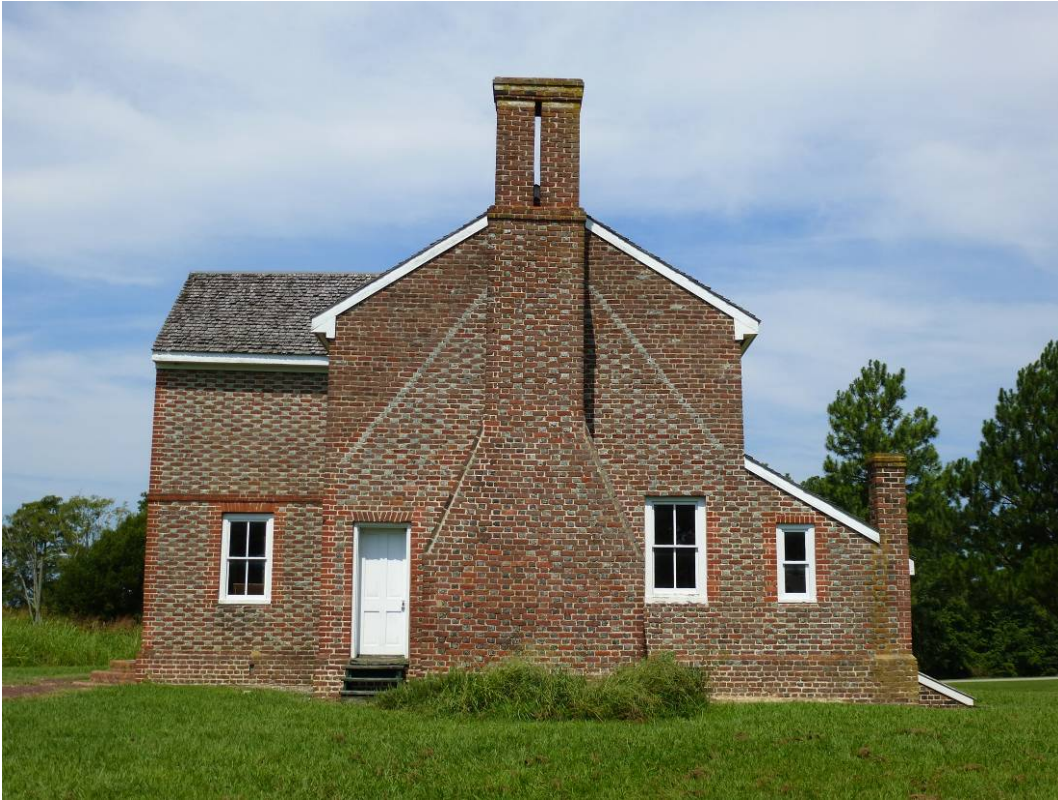
Figure 19. Southeast elevation with original chimney (ERDC-CERL, 2012).

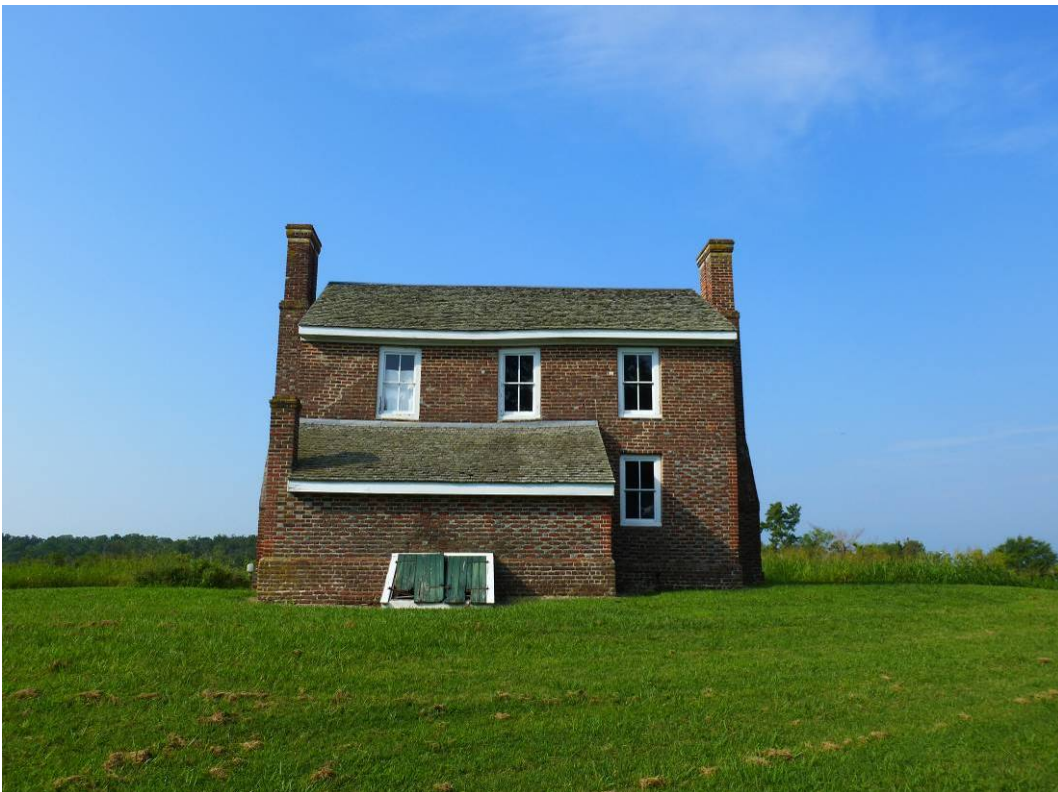
Figure 20. Northeast elevation (ERDC-CERL, 2012).

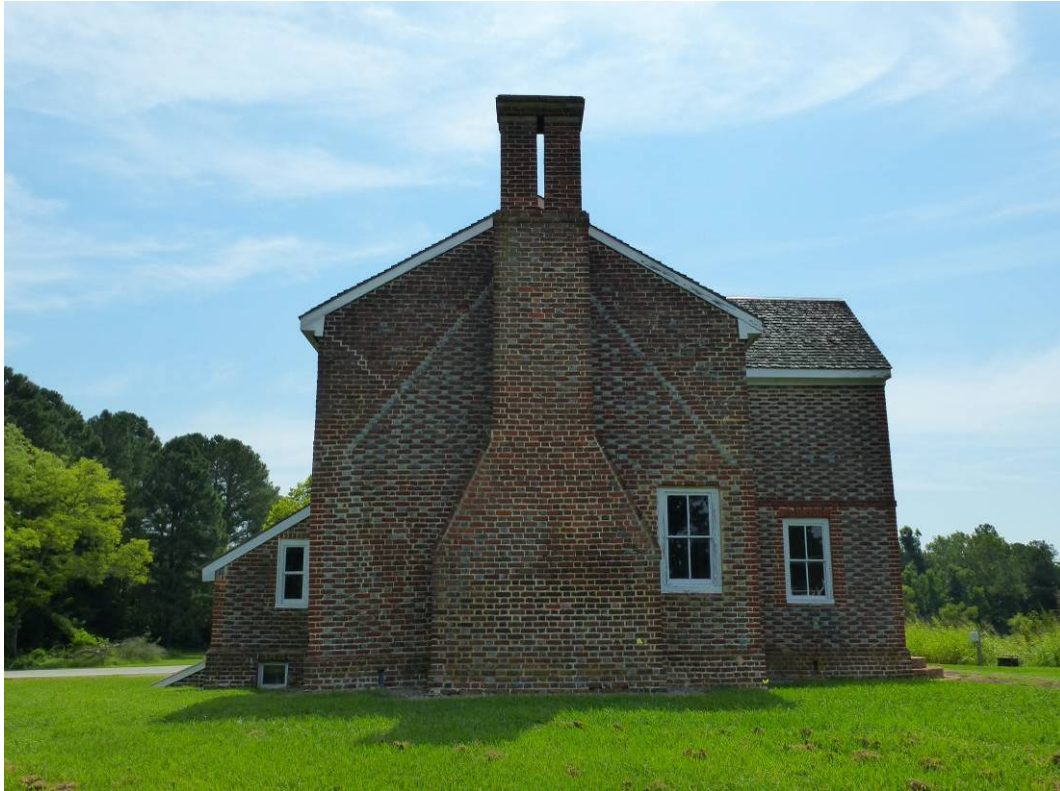
Figure 21. Northwest elevation with original chimney (ERDC-CERL, 2012).

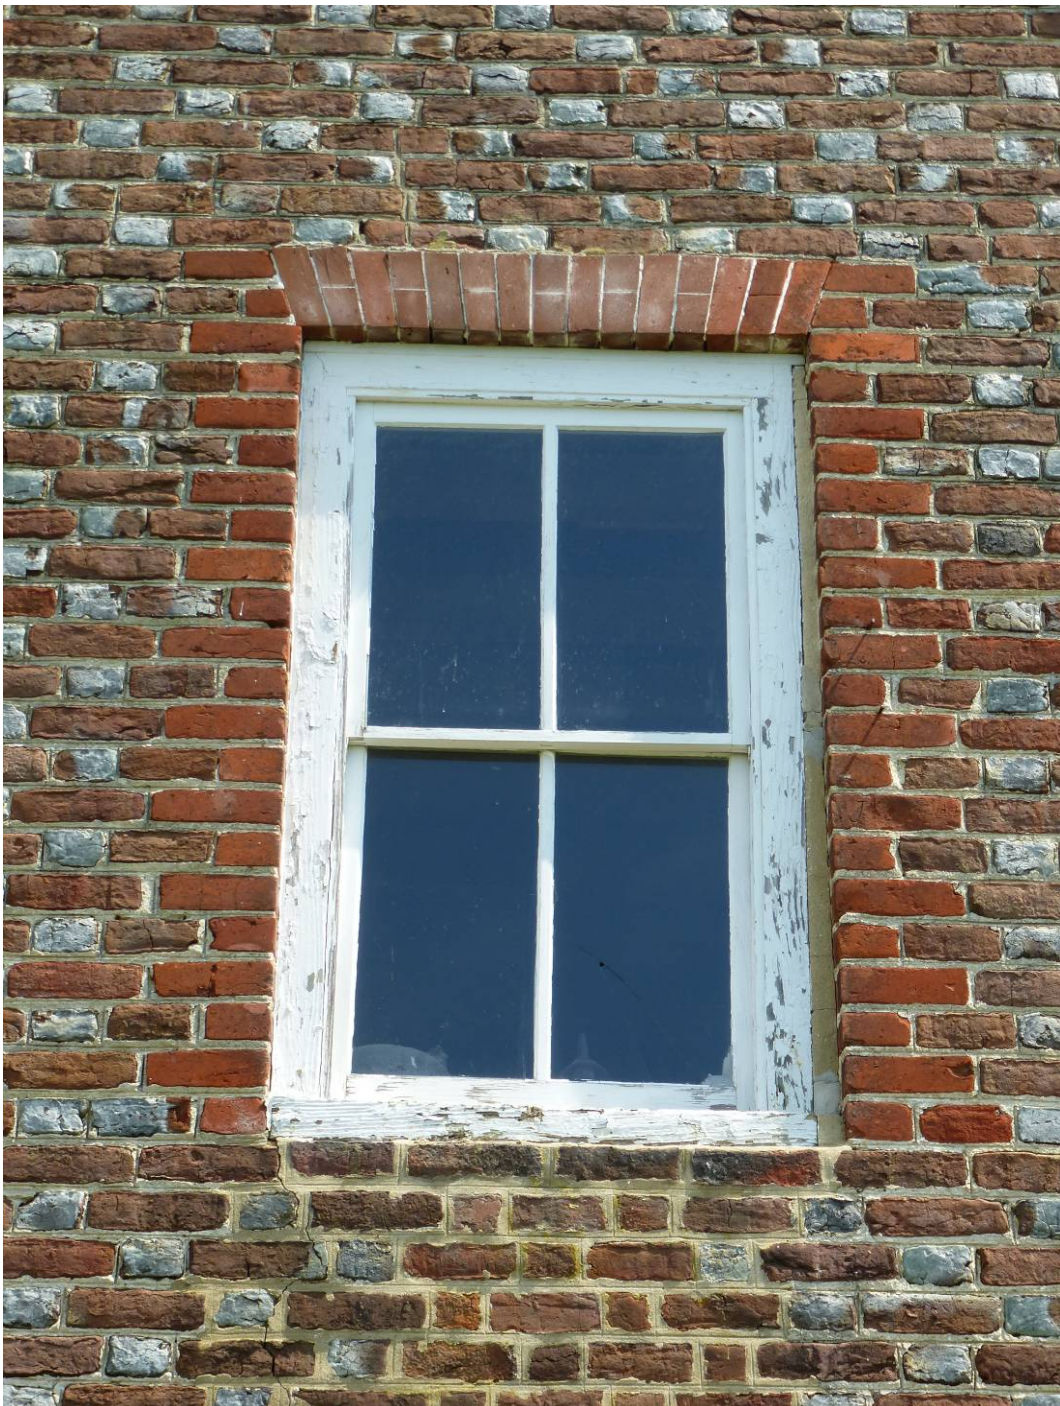
Figure 22. Preserve the wood two-over-two windows, including the rubbed brick lintel and jamb on the second floor (ERDC-CERL, 2012).

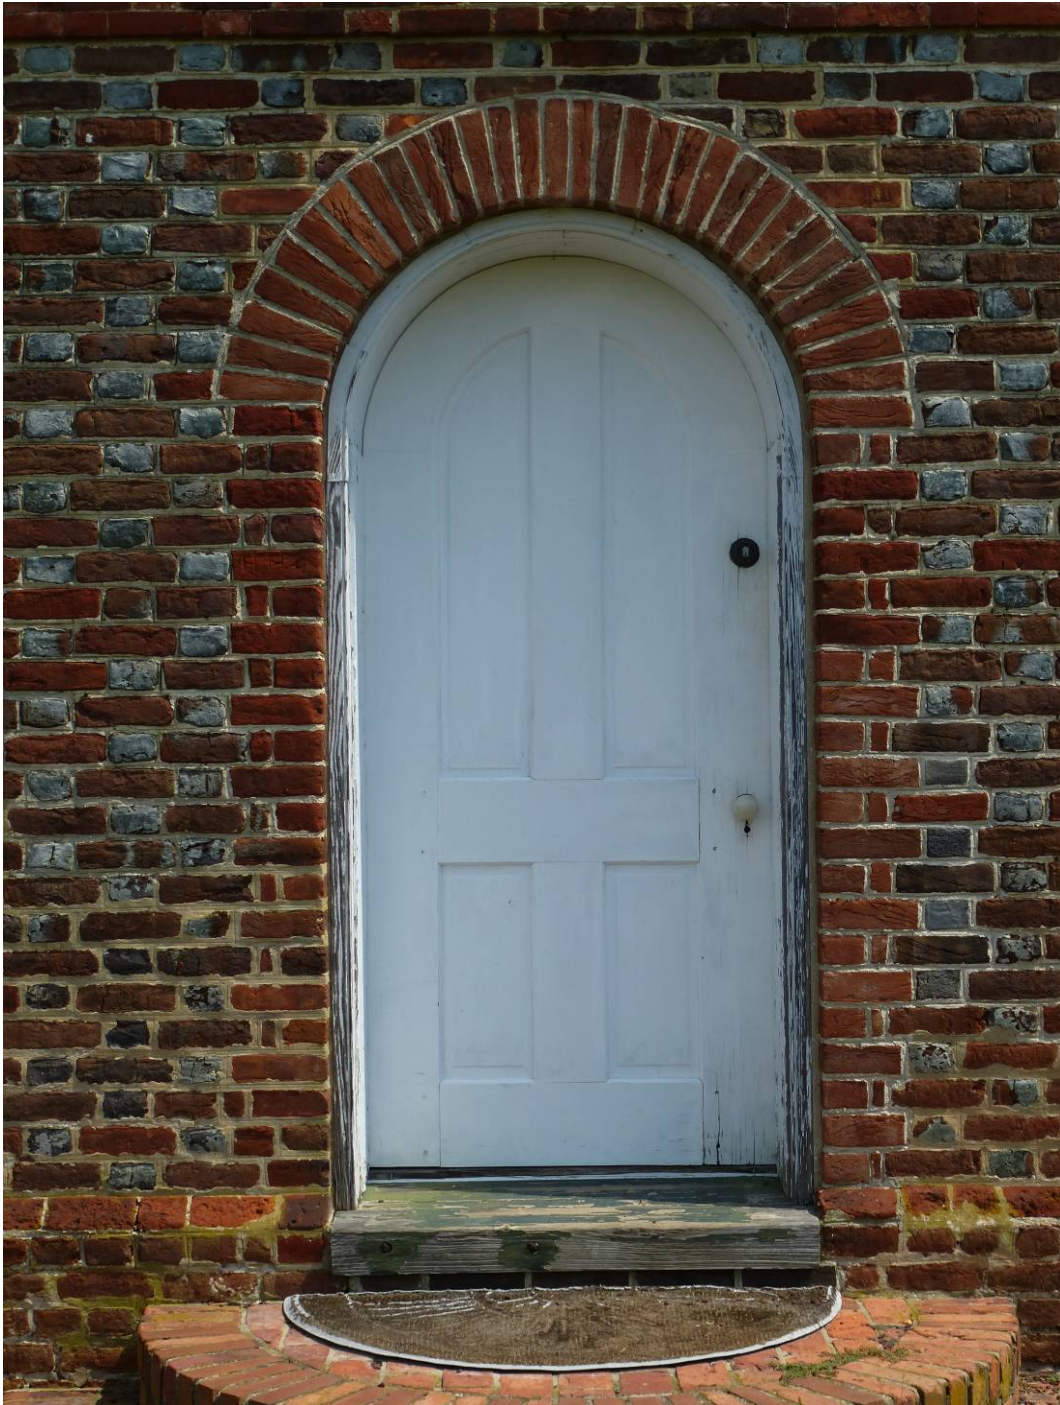
Figure 23. Preserve the arched wood front door, including the rubbed-brick arched lintel and jamb, as well as the brick steps in front of the door on the southwest elevation (ERDC-CERL, 2012).

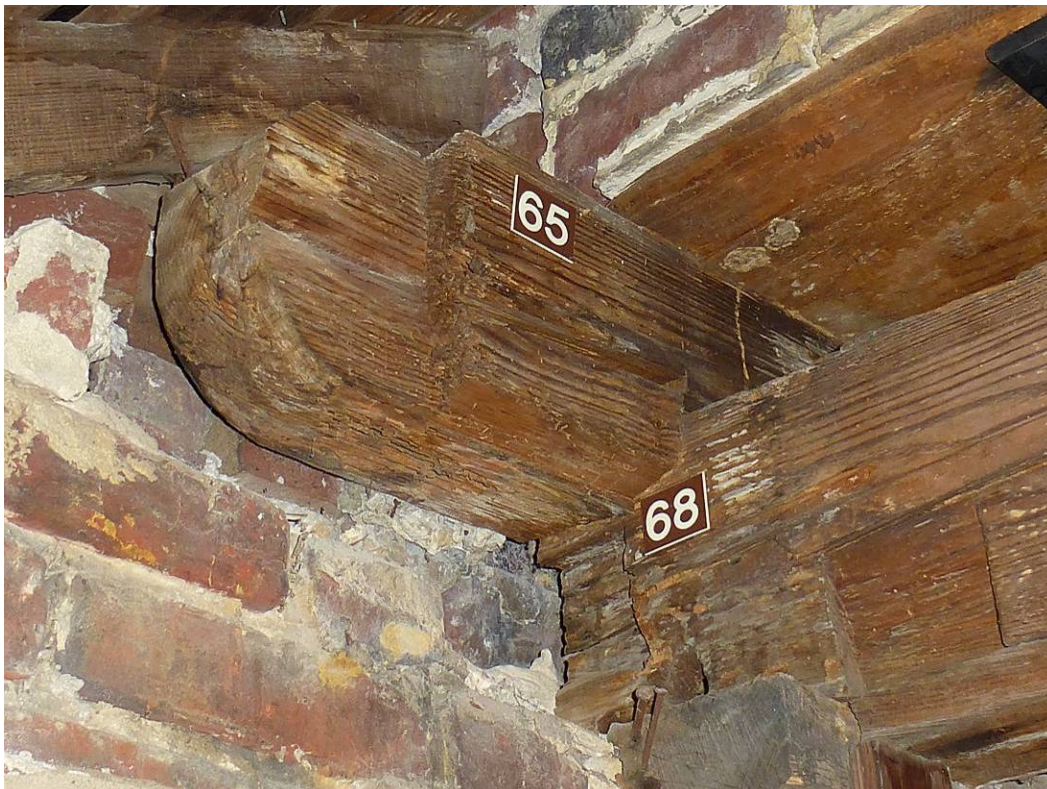
Figure 29. Original end joists (#65) along with other wood structural members in the Matthew Jones House should be maintained and preserved (ERDC-CERL, 2012).

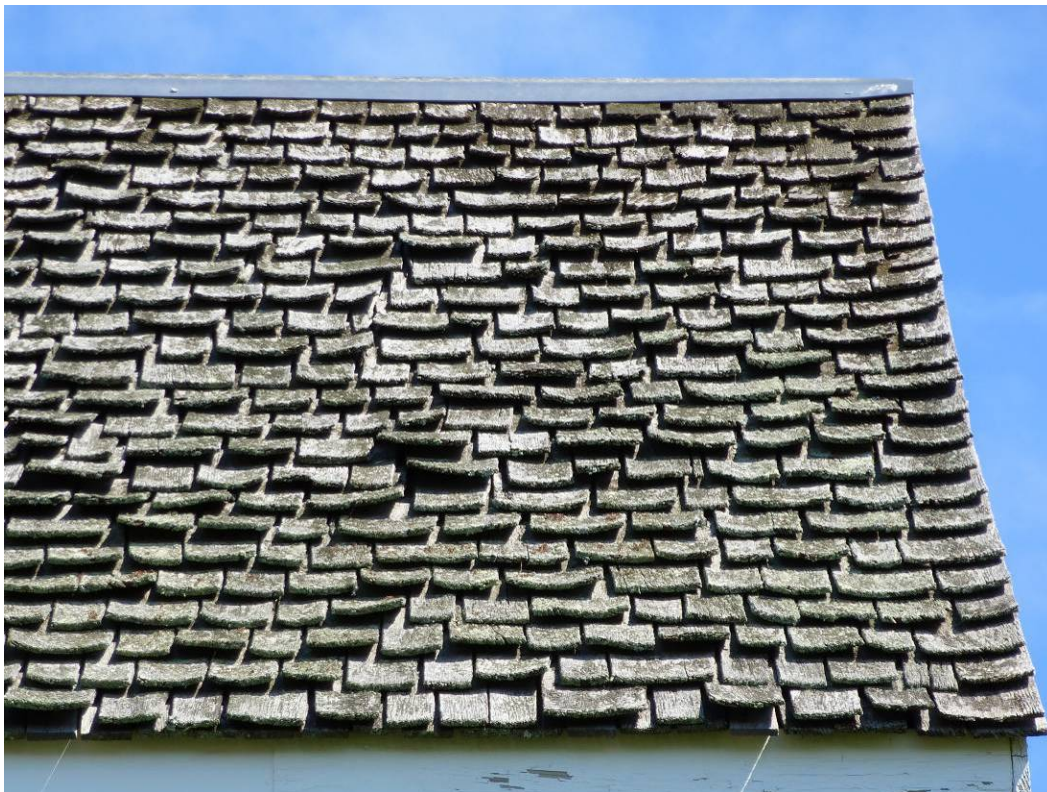
The current wood shingle roof is not original to the Matthew Jones House. It is a replacement roofing system, probably installed during the 1993 preservation efforts. It is however, in-kind to that of the original material and design intent. The condition of the roof is poor (Figure 30).

Figure 30. Wood shingle roof on main block gable, porch tower gable, and shed room (rear chamber) roof (ERDC-CERL, 2012).

The failing wood shingles need to be addressed immediately. The system components of the roof are no longer working properly creating gaps in the roof allowing water and exterior elements to penetrate into the structure. The current installation of the shingles is shown that the shingles do not overlap each other therefore creating gaps between the shingles. Replacement of the roofing material may not be an adverse effect depending on the type of replacement material used; however, the roof is such a main character-defining feature that SHPO concurrence is recommended.

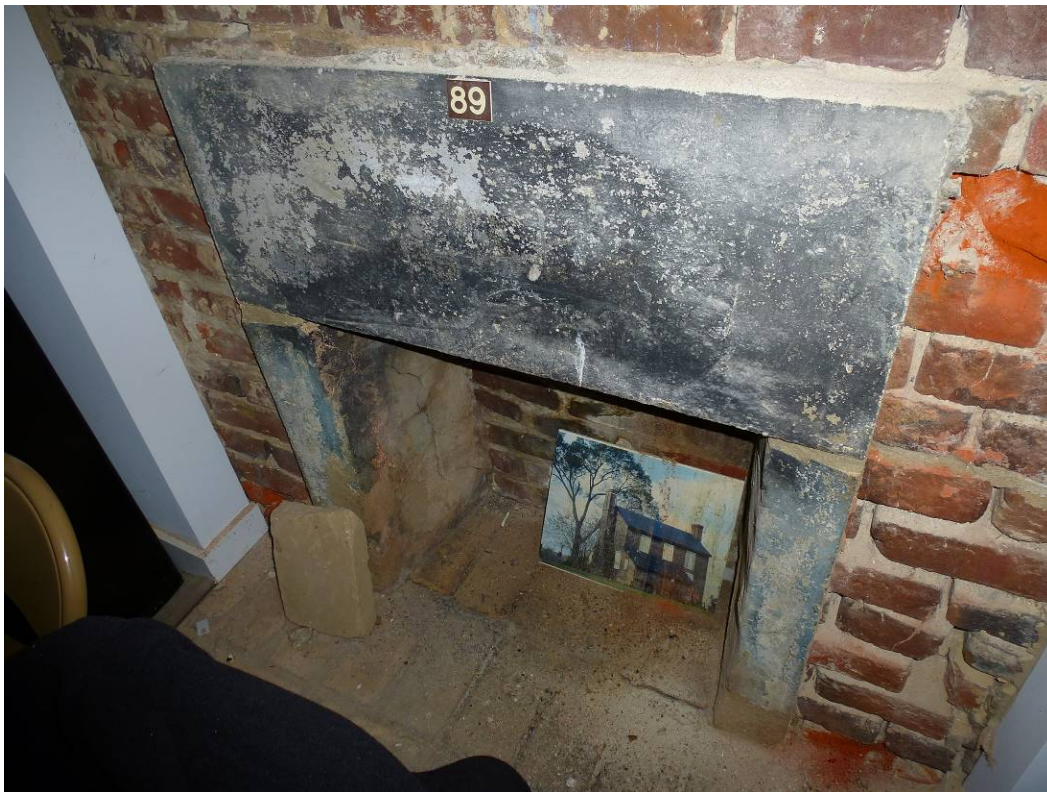
The interior of the cellar is Level 4; however, the original earthfast members visible in the cellar should be preserved. The small closet tucked under the stair passage is Level 4, as well as the second-floor chamber over the dining room. The brick fireplace should be preserved in this room (Figure 32 and Figure 37–Figure 43).

Figure 32. Fireplace on the southeast wall in the second-floor chamber room should be preserved (ERDC-CERL, 2012).

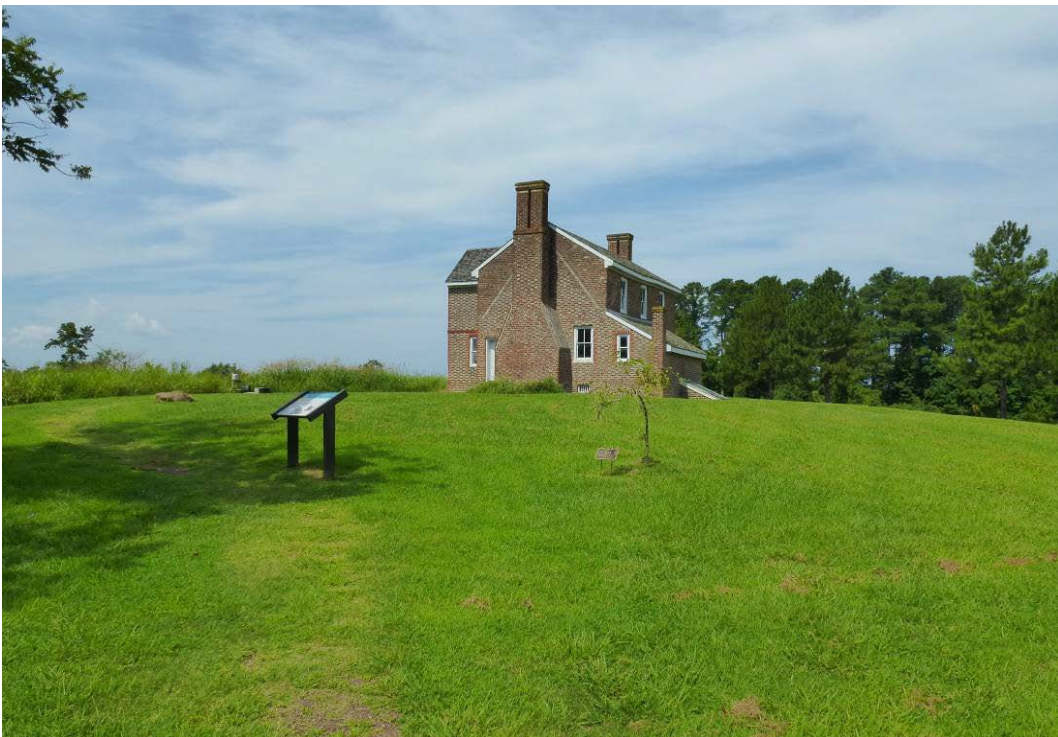
Figure 45. View from parking area towards the Matthew Jones House, looking southwest (ERDC-CERL, 2012).

- all walks are not kept clear of debris and overgrown plantings (Figure 45 and Figure 46), and/or
- the wood fence that stretches along the north side of the building is in need of repair (Figure 50), and

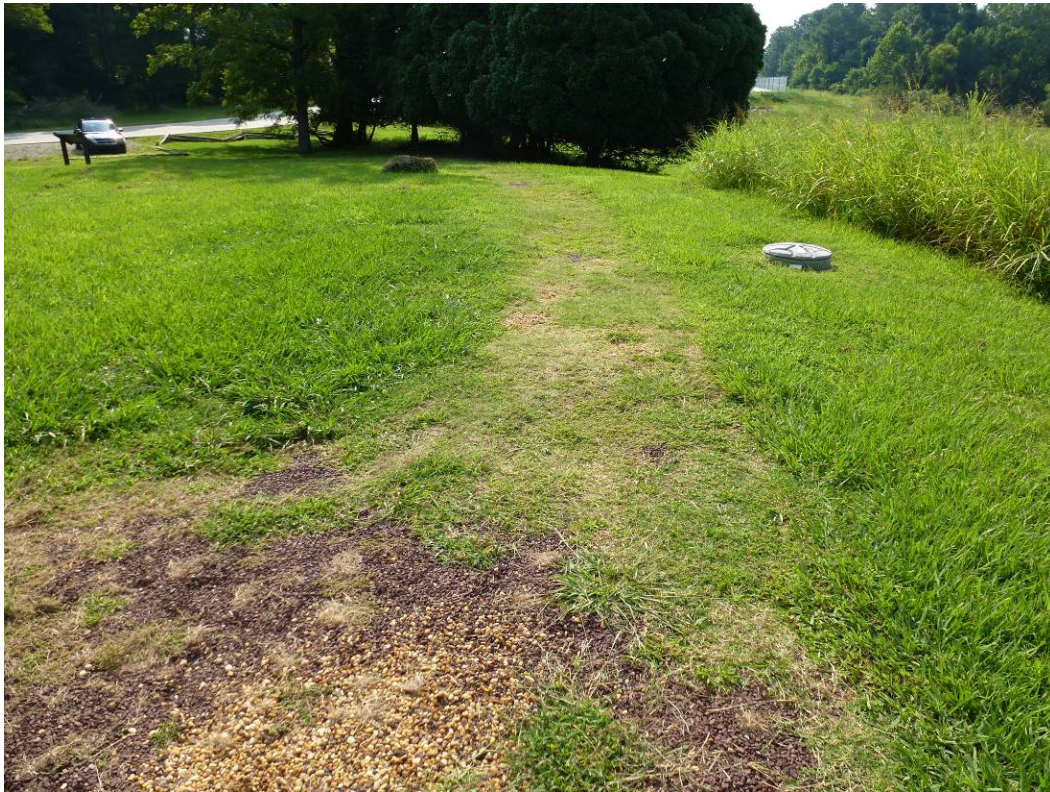
Figure 46. Path from parking area to the house needs to be cleared of vegetation and more defined (ERDC-CERL, 2012).

- The grounds are maintained and are on a regular mowing schedule, and
- the path from the paved lot to the front entrance of the house should be more defined by using crushed oyster shell to fill the walk path (Figure 51), and

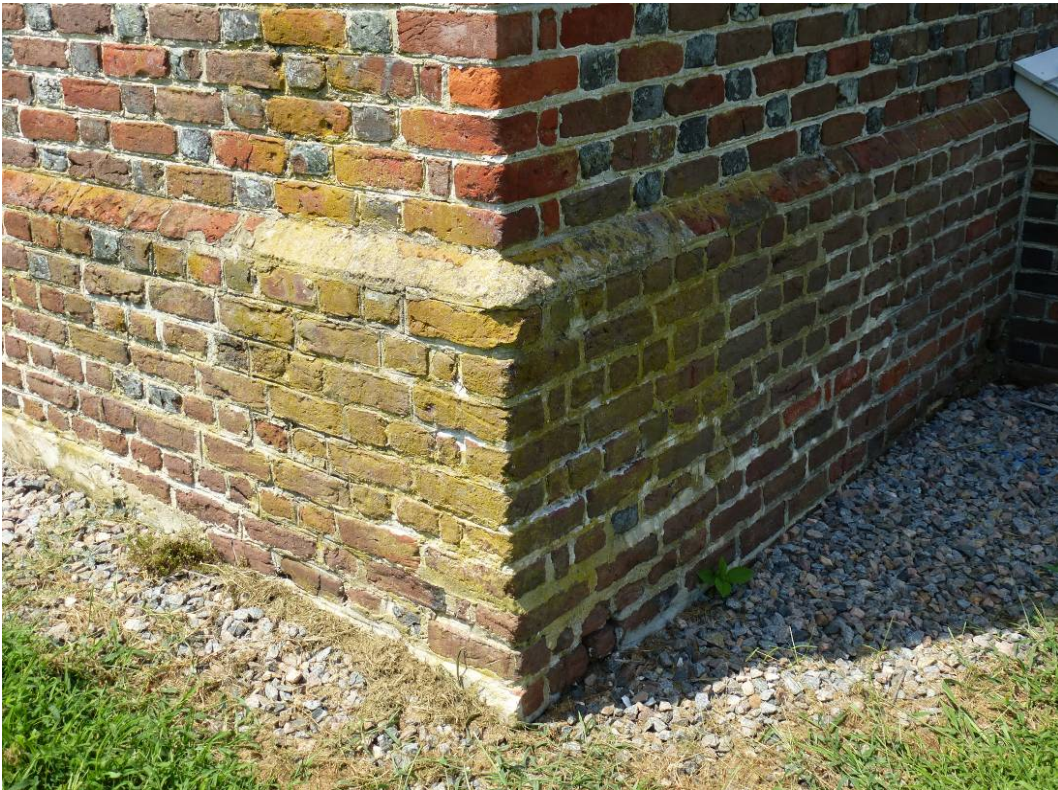
Figure 48. The current pebble rock that is located around the perimeter of the house (ERDC-CERL, 2012).

- large gravel around the perimeter of the house and no slope or soil drainage system are promoting the deterioration of the base of the house as a direct result of water splashing off the gravel (Figure 48), and

The Matthew Jones House was not designed with gutters and downspouts. Therefore the water that is shed from the edge of the roof falls directly at the base of the building. This issue allows rainwater to hit the ground and splash onto the brick exterior walls, causing the water to travel towards the house instead of away from it. The ground and site immediately adjacent to the structure need to be sloped away from the brick facades. This can be accomplished either through grading the soil, installing a French drainage system, or combining both techniques.

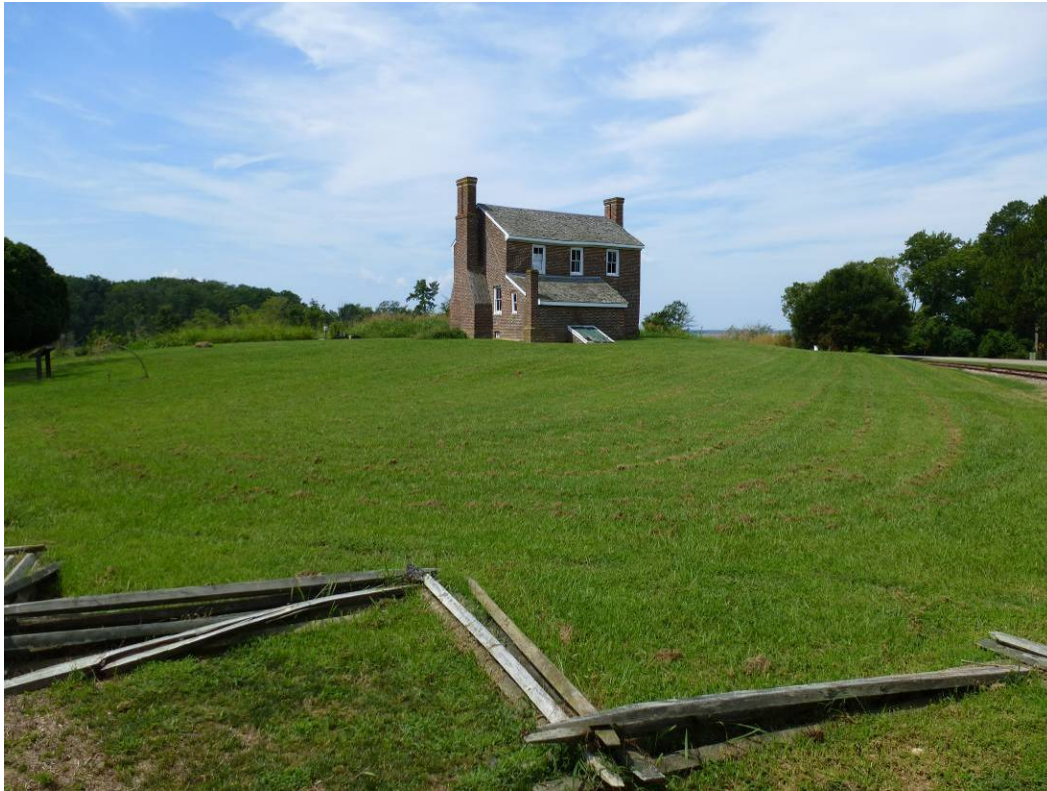
Figure 49. Dismantled wood fence needed to be restructured along the easterly side of the house (ERDC-CERL, 2012). This work was done in 2013 by soldier volunteers (see Figure 50).

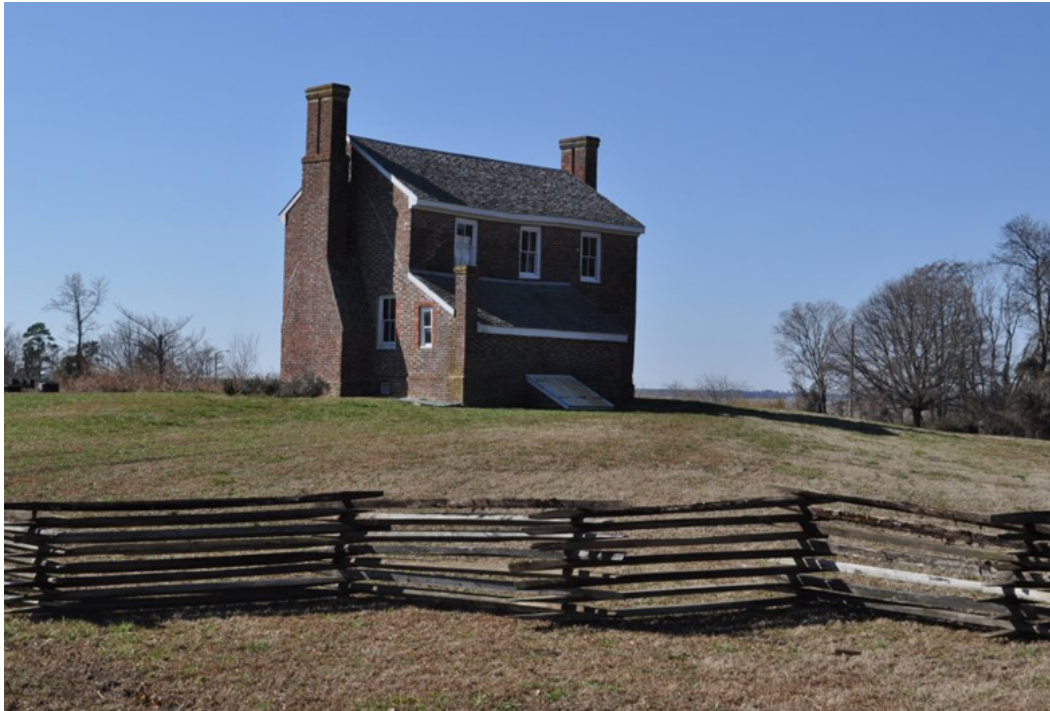
easterly side of the property) has been reconstructed into a fence again by soldiers who volunteered with the 2013 reconstruction efforts (Figure 50).

Figure 50. Fort Eustis CRM staff and soldiers, who volunteered their time, have rebuilt the fence (Fort Eustis Cultural Resources, 2013).

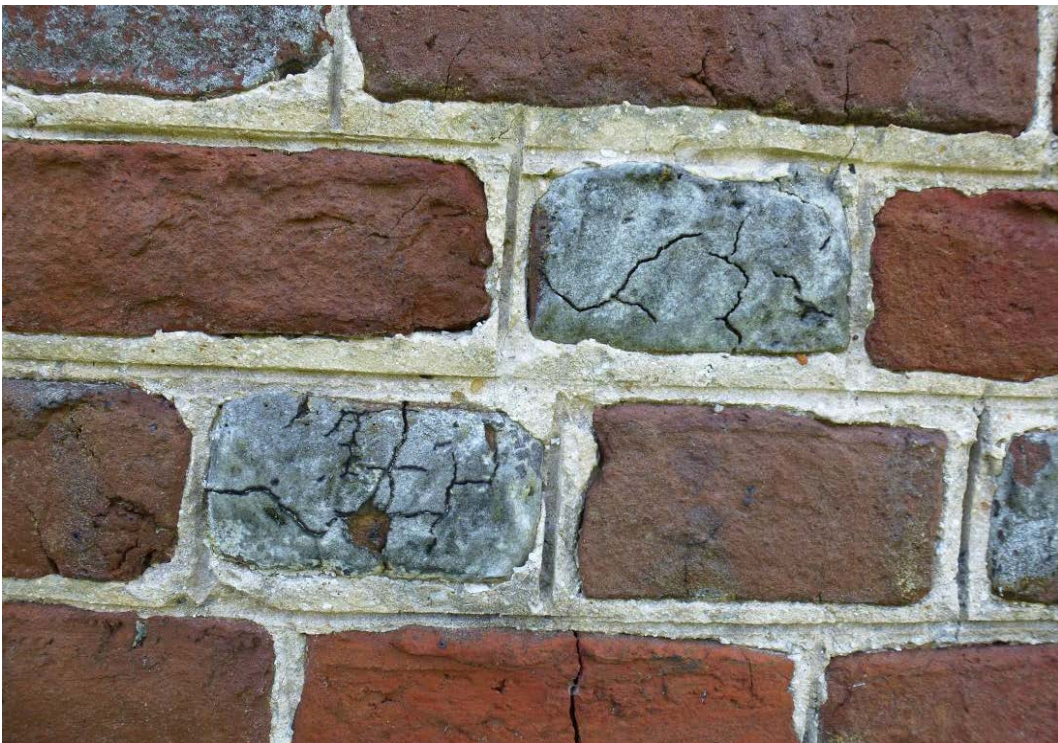
Figure 60. Glazing on header bricks is failing due to the evidence of crazing effects within brick (ERDC-CERL, 2012).

*Crazing* is the formation of a pattern of tiny cracks or crackles in a glaze (Figure 60 and Figure 61). Unless the cracks visibly extend into the porous tile body beneath the glaze, crazing should not be regarded as highly serious material failure. It does, however, tend to increase the water absorption capability of the glazed unit. To date, no completely effective treatment has been developed for this condition.<sup>27</sup>

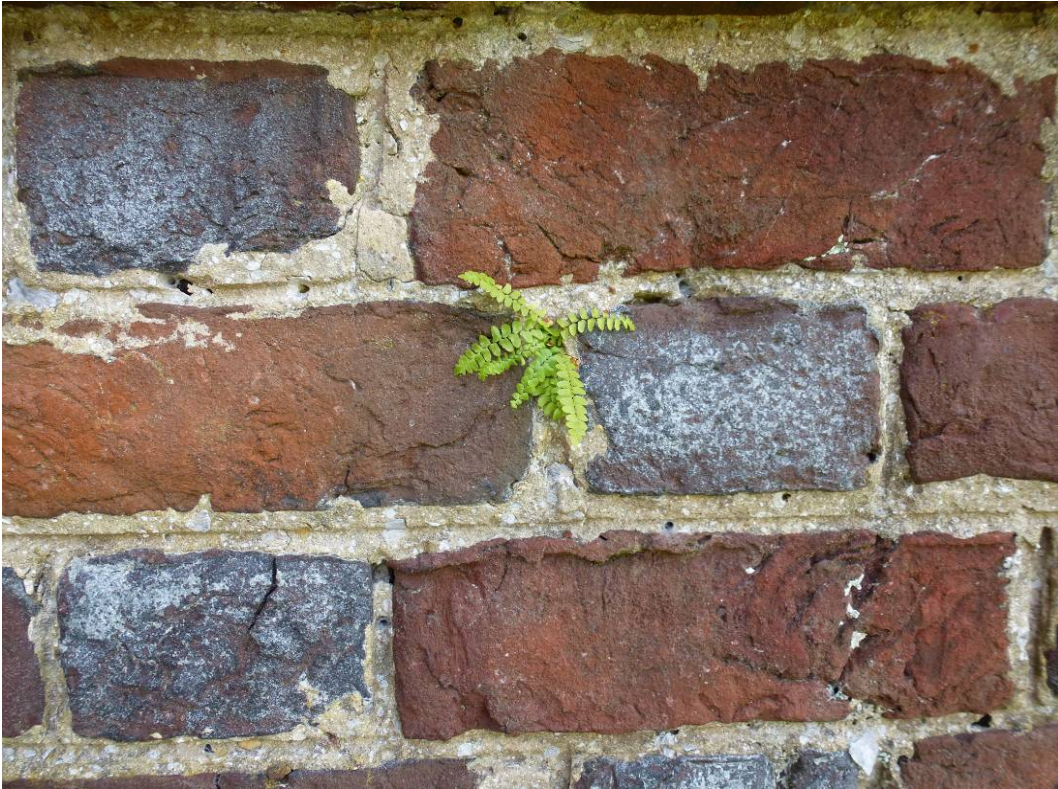
Figure 63. Vegetation growth within brickwork (ERDC-CERL, 2012).

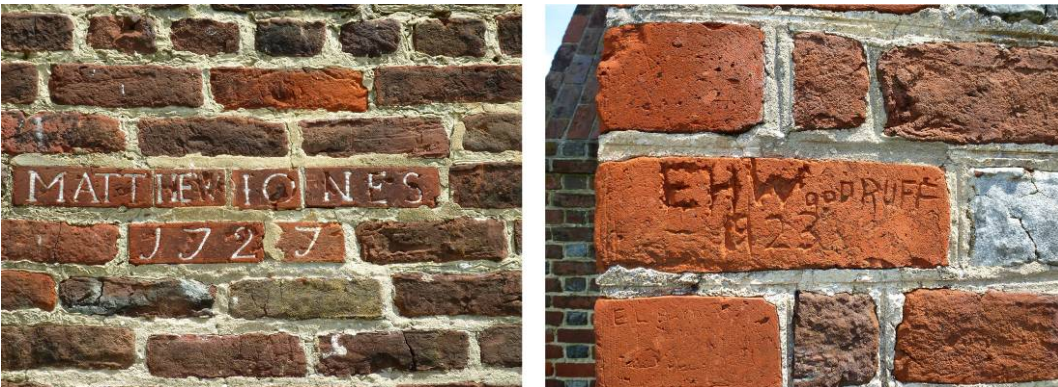
Figure 64. Etched brick (ERDC-CERL, 2012).

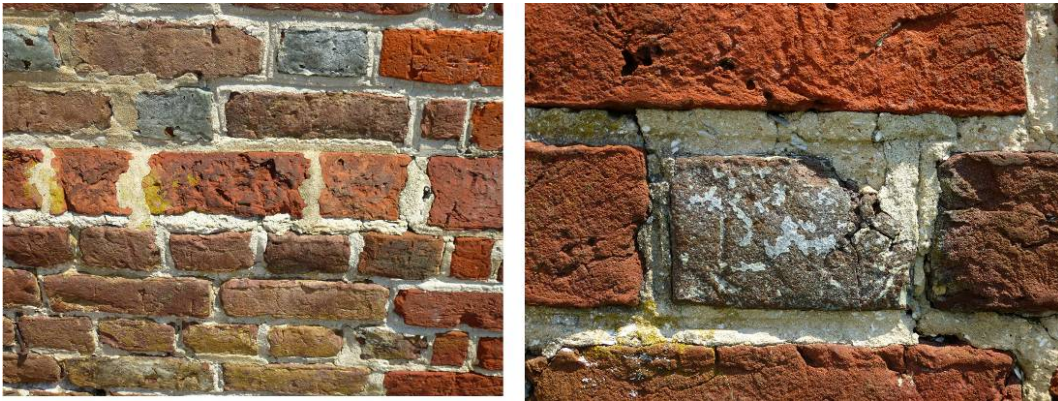
Figure 65. Incorrect mortar and excessive mortar used in previous repairs to the exterior brickwork (ERDC-CERL, 2012).

The masonry joints are in good condition. Some of the previous repointing jobs do not match the historic mortar in characteristics or color, such as the “grapevine” joint that was historically used on the Matthew Jones House (Figure 65–Figure 67). Only if mortar has decayed to the point where water penetration will be a problem should repointing be allowed, however.

- the brick and mortar is structurally and architecturally intact, and
- poor patch work over parts of the brick and mortar will need to be replaced (Figure 62 and Figure 65–Figure 67), and
- maintenance of the brick and mortar is needed for it to continue to function as it was designed, and
- cracks need to be evaluated and assessed to determine the cause and severity of the major cracks, and
- major cracks need to be repaired to prevent moisture penetration, and
- cracks need to be monitored on a regular basis, and
- damaged surfaces should be cleaned and repaired as per preservation standards laid out in this manual (Figure 56–Figure 58), and

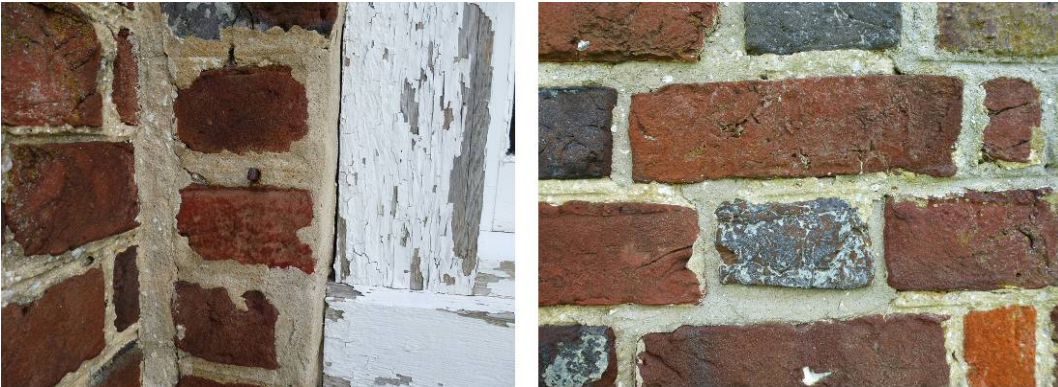
Figure 66. Examples of poor craftsmanship with replacement mortar (ERDC-CERL, 2012).

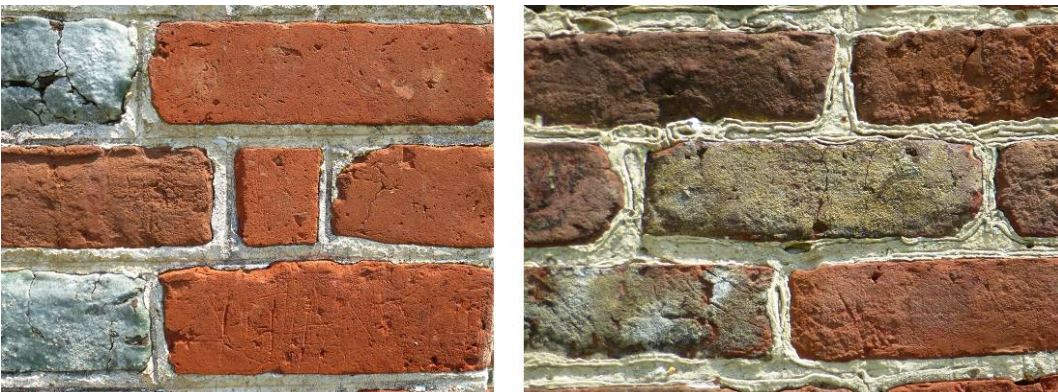
Figure 67. Comparison photographs: Correct technique for grapevine mortar joint on the left compared to incorrect technique on the right (ERDC-CERL, 2012).

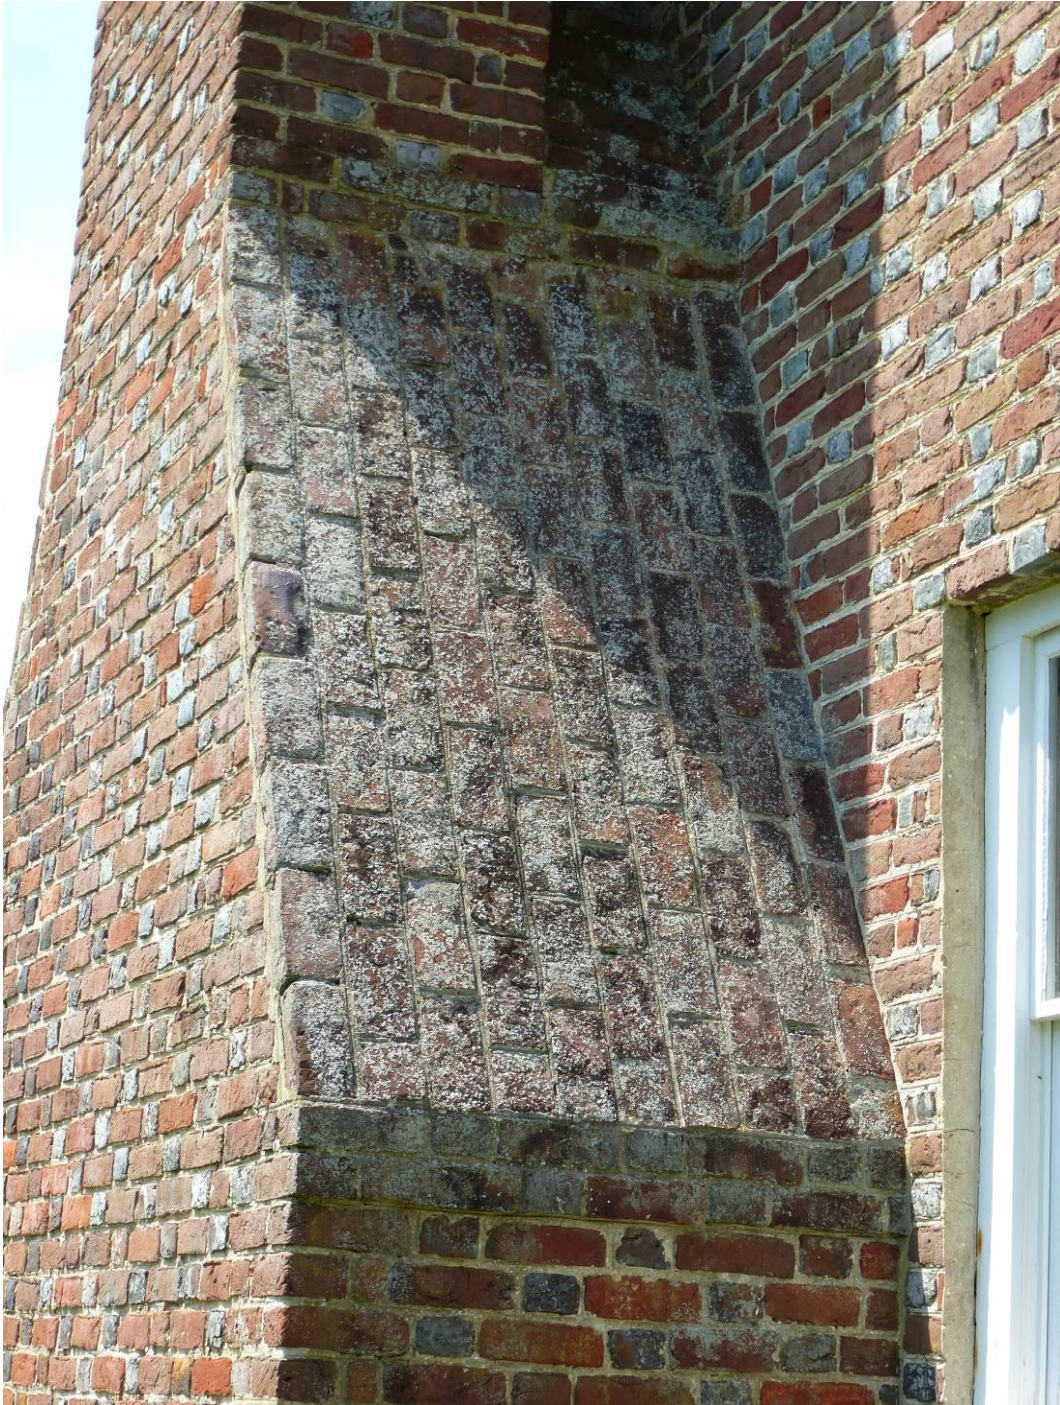
Figure 74. Efflorescence on the chimney brickwork (ERDC-CERL, 2012).

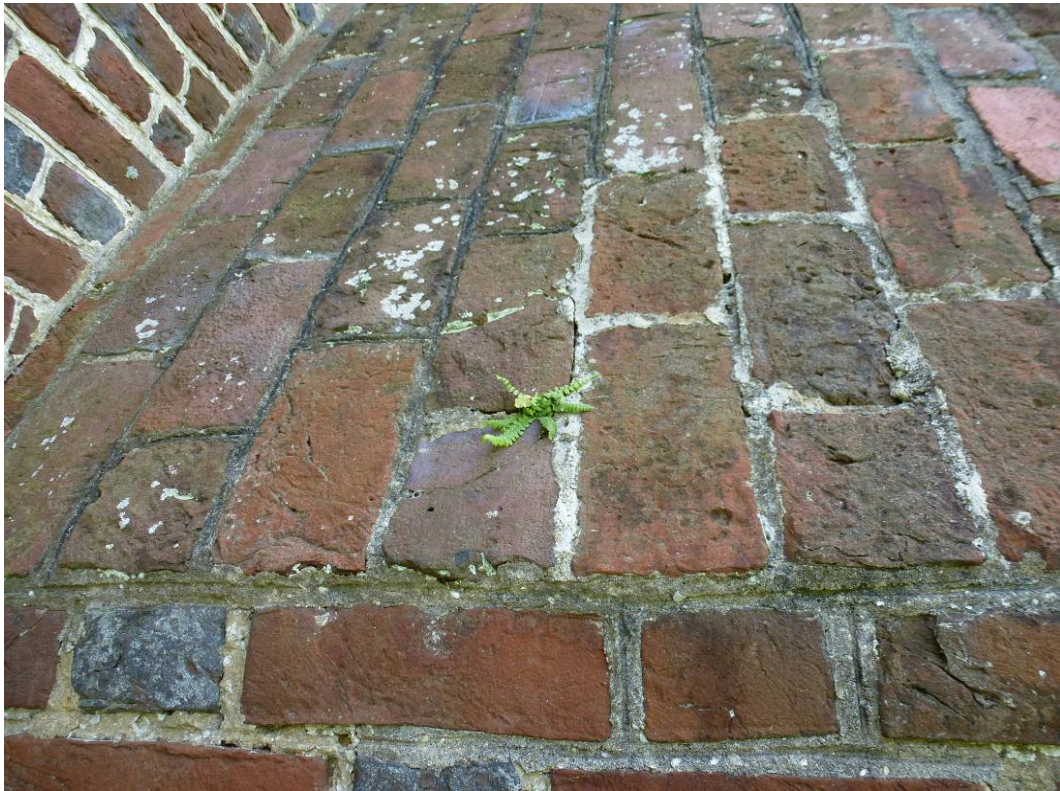
Figure 75. Vegetation growth on chimney brickwork (ERDC-CERL, 2012).

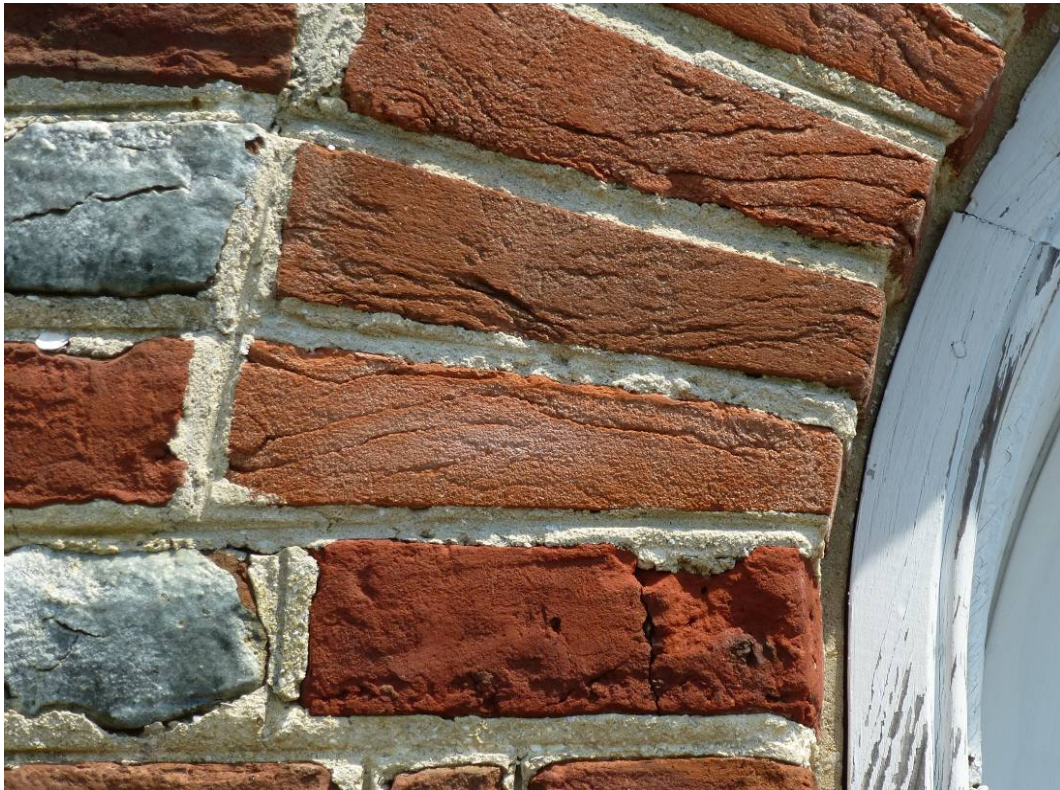
Figure 83. Close-up view of replacement bricks above arched door on the southwest elevation (ERDC-CERL, 2012).
